**SHEPHERD**  
**HOME REPORT**

57 Maitland Street  
DUNFERMLINE  
KY12 8AF  
04/02/2014

# Single Survey

<b>Property address</b>	57 Maitland Street Dunfermline KY12 8AF
<b>Customer</b>	
<b>Customer address</b>	
<b>Prepared by</b>	J & E Shepherd
<b>Date of inspection</b>	28th January 2014

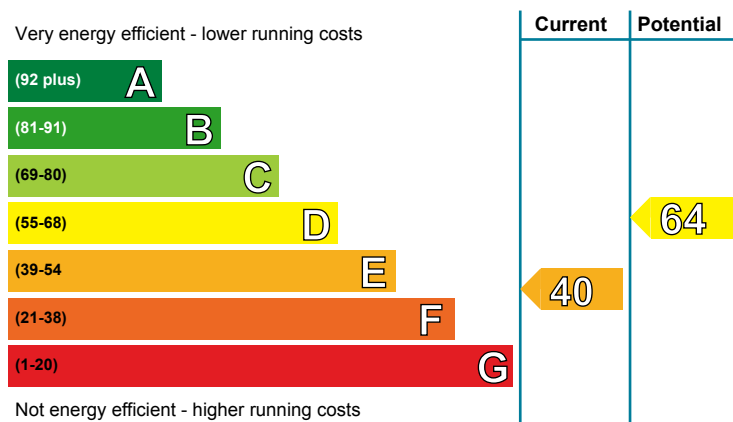
## Energy Efficiency Rating

This graph shows the current efficiency of your home, taking into account both energy efficiency and fuel costs. The higher this rating, the lower your fuel bills are likely to be.

Your current rating is **band E (40)**. The average rating for a home in Scotland is **band D (61)**.

The potential rating shows the effect of undertaking all of the improvement measures listed within your recommendations report.

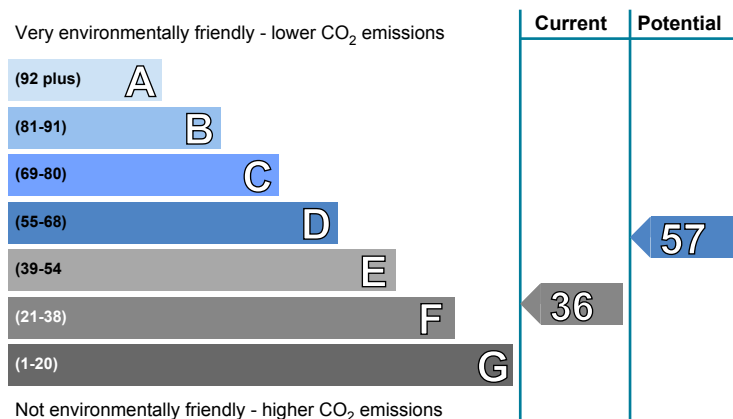
## Environmental Impact (CO<sub>2</sub>) Rating

This graph shows the effect of your home on the environment in terms of carbon dioxide (CO<sub>2</sub>) emissions. The higher the rating, the less impact it has on the environment.
