HOME REPORT

22 Blairwood Terrace
Oakley
DUNFERMLINE
KY12 9QG
25/04/2014

Single Survey

Property address	22 Blairwood Terrace Oakley Dunfermline KY12 9QG
-------------------------	---

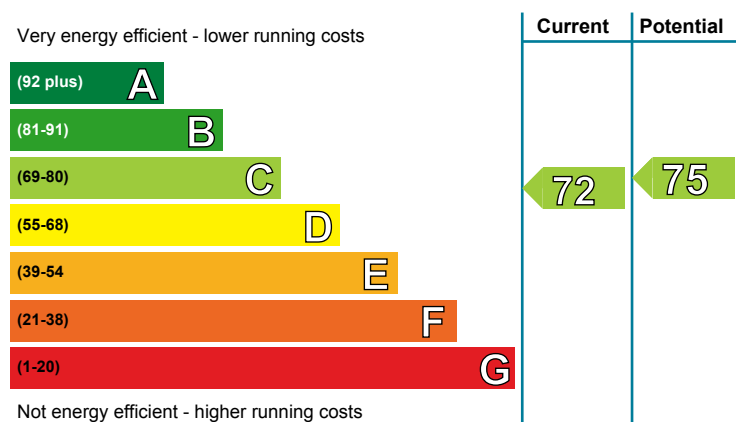
Energy Efficiency Rating

This graph shows the current efficiency of your home, taking into account both energy efficiency and fuel costs. The higher this rating, the lower your fuel bills are likely to be.

Your current rating is **band C (72)**. The average rating for a home in Scotland is **band D (61)**.

The potential rating shows the effect of undertaking all of the improvement measures listed within your recommendations report.

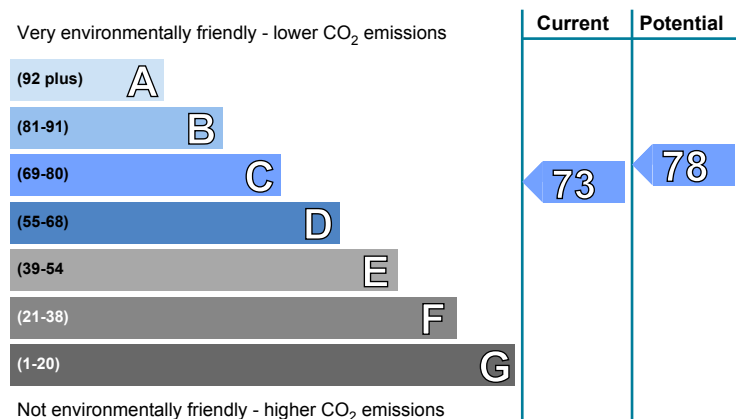
Environmental Impact (CO₂) Rating

This graph shows the effect of your home on the environment in terms of carbon dioxide (CO₂) emissions. The higher the rating, the less impact it has on the environment.
