50e High Street
COWDENBEATH
KY4 9NE

HOME REPORT

Single Survey

Date of inspection	3rd March 2016
---------------------------	----------------

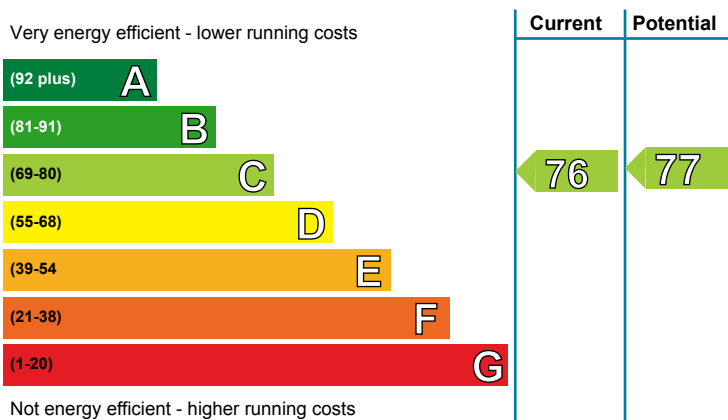
Energy Efficiency Rating

This graph shows the current efficiency of your home, taking into account both energy efficiency and fuel costs. The higher this rating, the lower your fuel bills are likely to be.

Your current rating is **band C (76)**. The average rating for EPCs in Scotland is **band D (61)**.

The potential rating shows the effect of undertaking all of the improvement measures listed within your recommendations report.
