## HOME REPORT

survey report on:

<b>Property address</b>	44b Townhill Road DUNFERMLINE KY12 0JD
<b>Customer</b>	Mr Craig Atherton
<b>Customer address</b>	46 Bellyeoman Road DUNFERMLINE KY12 0BB
<b>Prepared by</b>	DM Hall LLP
<b>Date of inspection</b>	29th April 2016

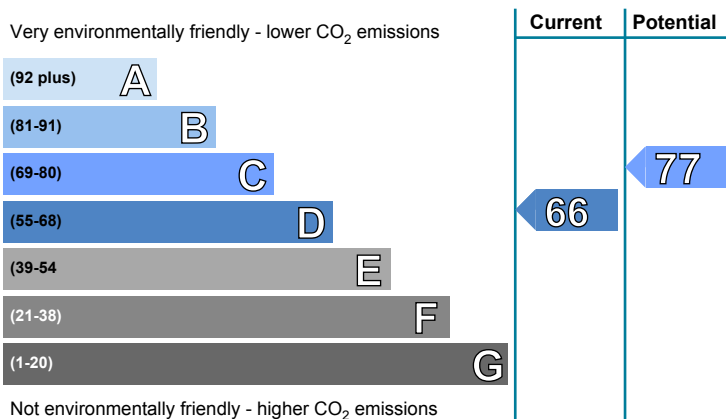
## Environmental Impact (CO<sub>2</sub>) Rating

This graph shows the effect of your home on the environment in terms of carbon dioxide (CO<sub>2</sub>) emissions. The higher the rating, the less impact it has on the environment.
