HOME REPORT

6 Moubray
Crook of Devon
Kinross
KY13 0UU

DM HALL
CHARTERED SURVEYORS

Single Survey

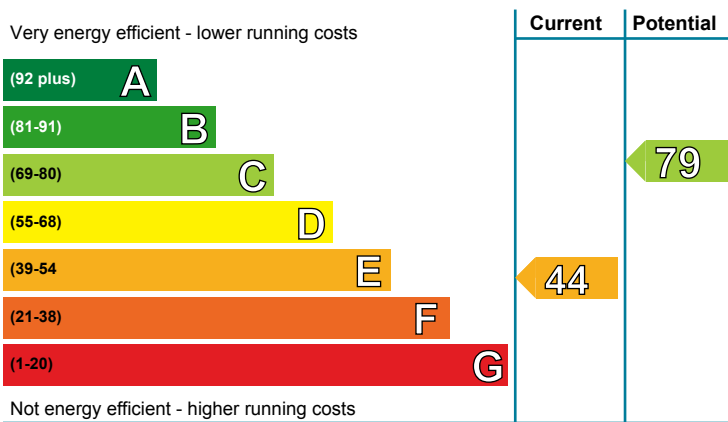
Energy Efficiency Rating

This graph shows the current efficiency of your home, taking into account both energy efficiency and fuel costs. The higher this rating, the lower your fuel bills are likely to be.

Your current rating is **band E (44)**. The average rating for EPCs in Scotland is **band D (61)**.

The potential rating shows the effect of undertaking all of the improvement measures listed within your recommendations report.

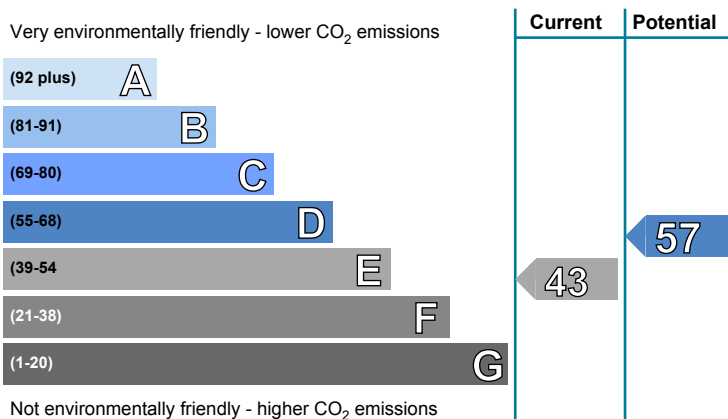
Environmental Impact (CO₂) Rating

This graph shows the effect of your home on the environment in terms of carbon dioxide (CO₂) emissions. The higher the rating, the less impact it has on the environment.
